PROJECT PORTFOLIO: PROPERTY NO:9

Les H

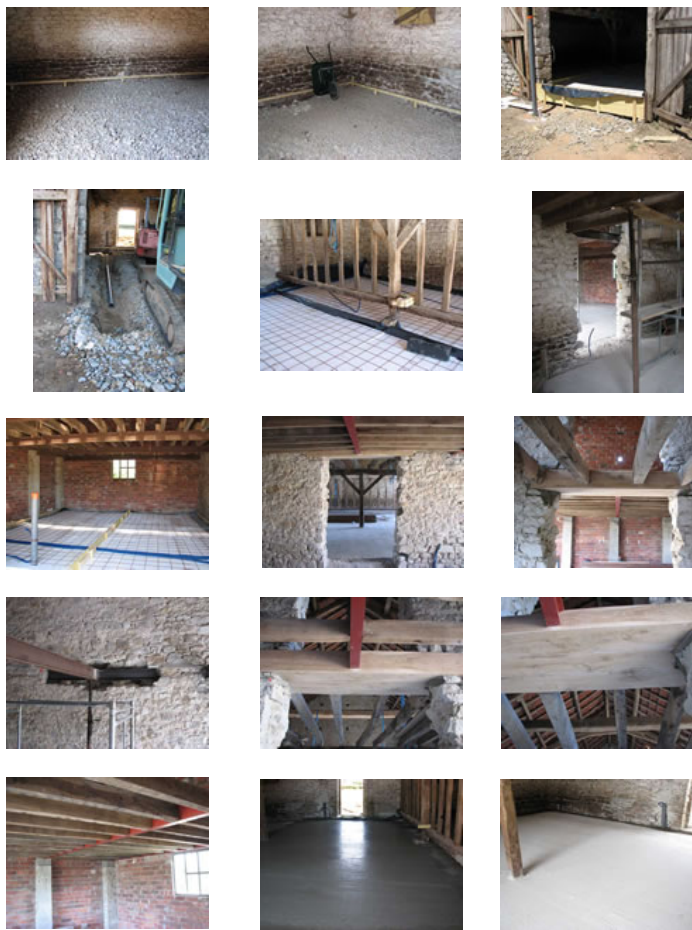
The floors were insulated with 50mm Deltisol, caged and 150mm of sub floor poured to create the sub floor. You may think the concrete depth was excessive (as we did) but the clients and architect insisted.

With the knock throughs (or openings) made the project is now ready for the advancement to make this barn into a home. These can be long roads to follow but the reward is priceless.
